## Halifax, West Yorkshire

### Transmission Tower Slope Stability Assessment

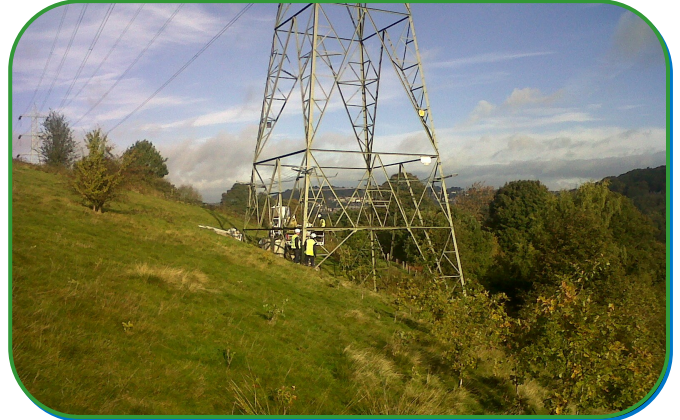
Following reports of structural deformation to an existing tower, **CGL** were appointed to undertake a topographical survey of the structure and adjacent ground levels at the transmission tower. This allowed **CGL** to design an intrusive investigation to determine the likely cause of deformation from which viable remedial solutions for the client were provided.

The resultant tower movement was identified to be attributable to two factors: a mining adit immediately beneath the tower appeared to have collapsed, and shallow lateral soil movement of the steep slope causing foundation movement and tower deformation.

- Stabilising foundation movements via dowels drilled through existing foundations,
- Installing cut-off drain upslope of the tower to limit the influence of groundwater, and
- Grout injection to stiffen the underlying ground within the locality.
