## Purbeck View School, Swanage

### Slope Stability Assessment

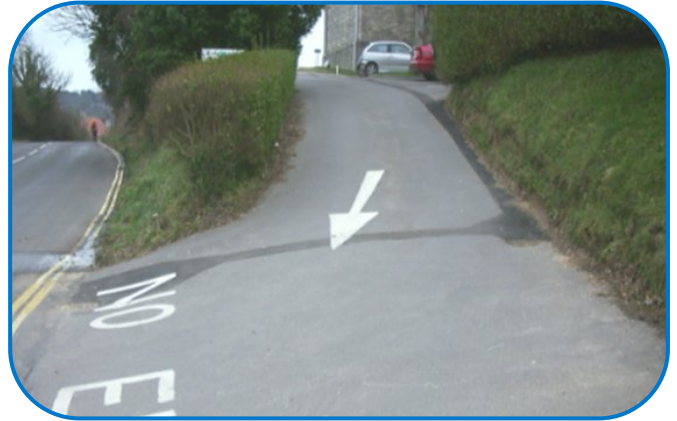
**CGL** undertook a site investigation and analysis to determine the stability of a slope showing signs of instability with cracking along its crest. The slope ranged in height to approximately 6m with a gradient between approximately 1:2 to 1:1.2 (v:h).

Badgers had also been burrowing into the slope, although efforts had been made to remove the badgers by licence consent.

building adjacent to the slope. The analysis was modelled using the SLOPE computer program. The analysis confirmed that the slope is unstable in its current profile.

**CGL** recommended a range of remedial options, varying according to site limitations and topography, necessary to stabilise the slope and achieve satisfactory long-term safety.
