## Hendon Lane, Finchley, London

### Slope Ability Analysis and Supervision

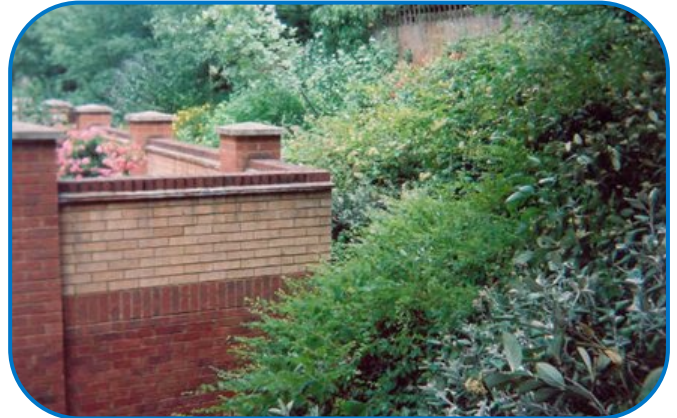
During May 2001 a significant proportion of the slope, some 60m long and 6m high, failed bringing with it most of the landscape vegetation.

The investigation and installed inclinometers confirmed a shallow depth rotational failure that was then analysed using *Oaysis* SLOPE.

Restoration measures involved the construction of counterfort drains dug by mini digger across the site, re-profiling and toe wall construction combined with restoration of the landscaping.
