## Undercliff, St Leonard's on Sea

### Geotechnical Investigation for Landslip and Retaining Wall Failure

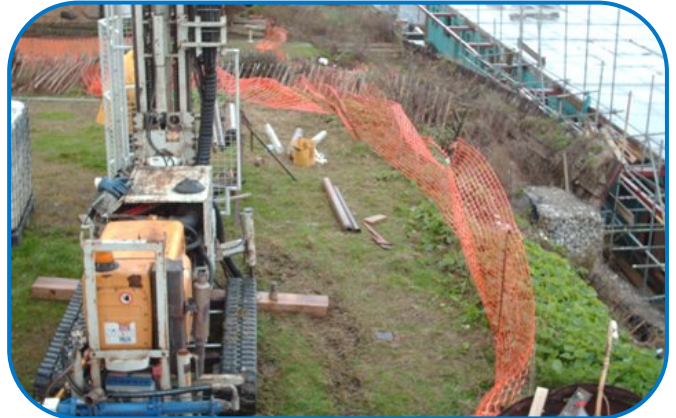
During development of the site on the down slope side, the existing passive support for the existing retaining wall was removed and replaced in part by alternative support. Due to inadequate design of new support the part sheet pile, part steel gabion retaining wall failed and rotated seaward into the development under construction. This movement in turn caused a substantial landslip within the residential gardens on the upper slope side, and put the existing residential properties on the upper side at potential risk.

Upon completion of the investigation works a full remedial scheme was designed and implemented.
